**Sustainable HVAC Systems**

- No Maintenance,
- Lower Life Cycle Costs,
- Better "IAQ" Indoor Air Quality

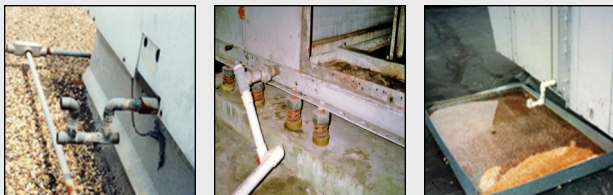
**Figure 1.** Typical trapped systems that meet industry codes

Despite the numerous failure modes common to the condensate trap, it is an integral part of the drain system now accepted as the “industry standard.” The success of this system depends upon the best possible trap design and effective maintenance by the building operator. But, there is no standard or useful guidance for performing either of these functions. The widely applicable national, and many local, plumbing codes state only that HVAC drain systems shall be trapped, leaving detail design to others. Drain systems like those shown in **Figure 1** are the results. Each of these systems meets applicable codes; that is, they are trapped. Successful maintenance is impossible, since none can effect successful condensate drainage. Most HVAC units in this country are equipped with the “industry standard” drain systems. The frequent and untimely failures of these systems impose costly

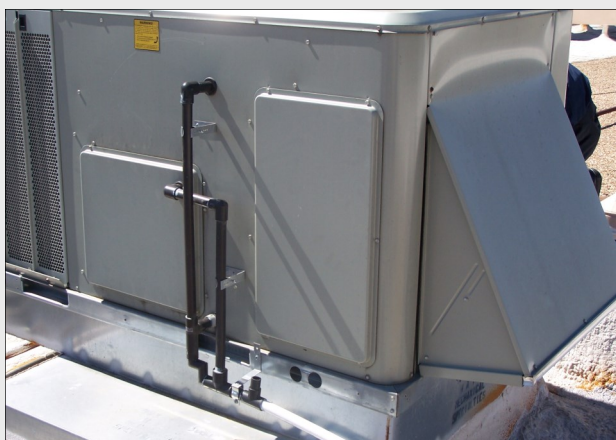
**Figure 4.** Typical installation of a CostGard™ Condensate Drain Seal System

In keeping with the savings it provides building owners, the system has been named: CostGard™ Condensate Drain Seal System. A typical installation on a rooftop unit is shown in **Figure 4**.
