Sustainable HVAC Systems

CostGard™

Condensate Drain Systems

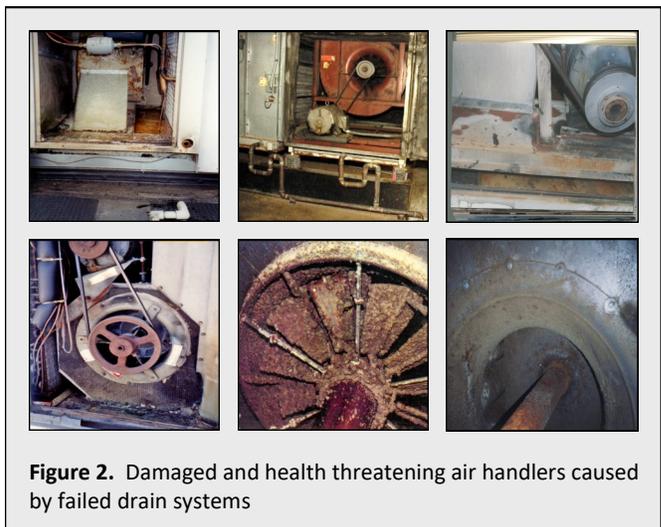
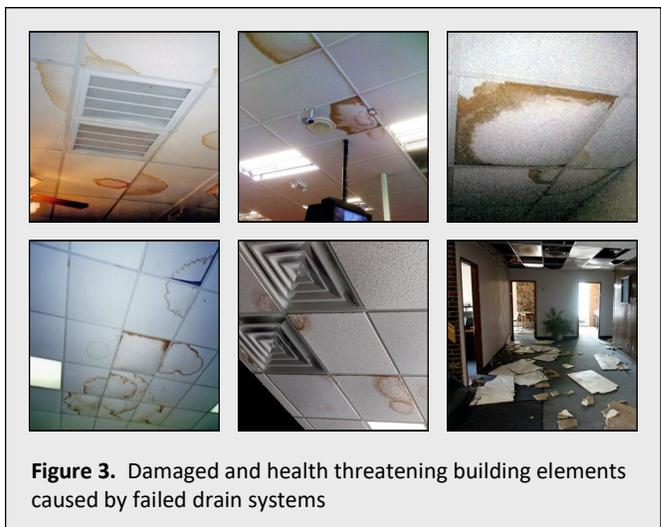
burdens on building owners in terms of health threats, property damage, service calls, maintenance effort, equipment life, and life cycle cost. The photographs in **Figures 2** and **3** illustrate the property damage caused by the failure of “industry standard” drain systems. The impact of these failures on health is appreciated only when it is realized that all air in the conditioned space passes through the contaminated air handlers several times per hour.

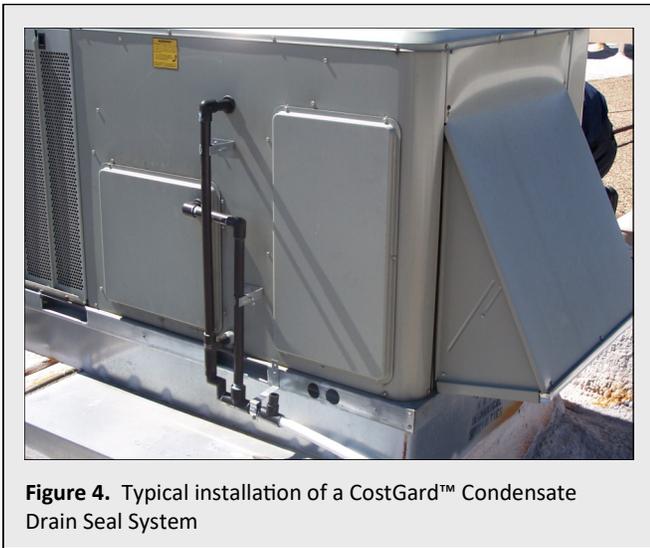
Figure 4. Typical installation of a CostGard™ Condensate Drain Seal System

In keeping with the savings it provides building owners, the system has been named: CostGard™ Condensate Drain Seal System. A typical installation on a rooftop unit is shown in **Figure 4**.
