CostGard™
Condensate Drain Seal
for
Roof Top Unit (RTU)
Draw-Through HVAC Systems

SUBMITTAL

RTU System Kit

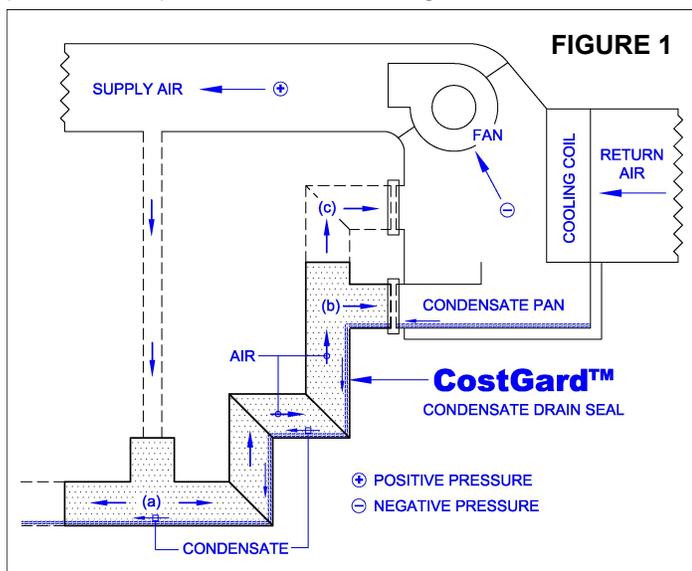
The CostGard™ Condensate Drain Seal is the result of over four years of engineering research and development. It makes use of the hydraulic and pneumatic forces present in all draw-through air handlers. It is simple, effective and reliable. It has no moving parts. How it operates is illustrated in Figure 1.

During both heating and cooling operations, the air seal is formed as follows:

Fresh air from the fan discharge is supplied to point (a) at a pressure slightly above atmospheric. Some of the air flows away from the HVAC unit; thus, preventing ingestion of outside air. A portion of the air returns to the HVAC unit, passing through points (b) and (c). The quantity of air returning to the unit is minimized by the high-pressure loss in the mitered elbows. This pressure loss plus the air flowing through the bypass connected at point (c) ensures that the air entering the condensate drip pan does not produce blowing and geysering and an aerosol mist. Condensate flows through the device without being trapped. At the same time, the counter-flow of condensate and air creates a pulsing action that ensures free passage of debris. Hence, the potential for freeze-up and flow blockage (common problems with traps) is nil.

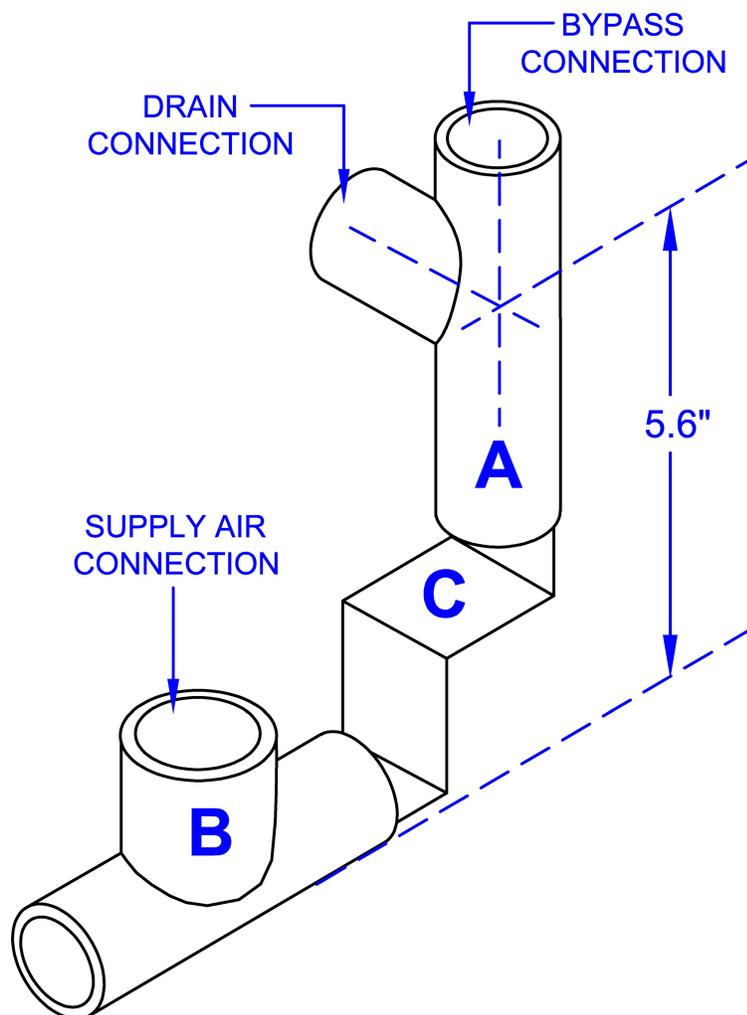
CostGard™ Configuration 56

The CostGard™ Condensate Drain Seal RTU System Kit is designed for draw-through air handlers, up to 30 tons, with 3/4" and 1" drains. For outdoor use, each kit consists of a UV inhibited CostGard™ Condensate Drain Seal, UV inhibited pipe and fittings, support brackets, grommets, and detailed installation instructions. As shown in the configuration chart below, 5.6" of depth is required for installation. Static pressure limits in the drain pan compartment range from -2.0" to -2.2" w.c. RTU System Kits are available for Carrier, Lennox, Trane, York, and others.

RTU System Kit - Configuration Chart
